<h1>FLARM FIRMWARE RELEASE NOTES</h1>	Date: 2022-06-06 Version: 1.1 Page: 1 of 45
FLARM Technology AG Industriestrasse 49 CH-6300 Zug		Document Number: <b>FTD-037</b>

# FLARM Firmware Release Notes

## Version 7.43

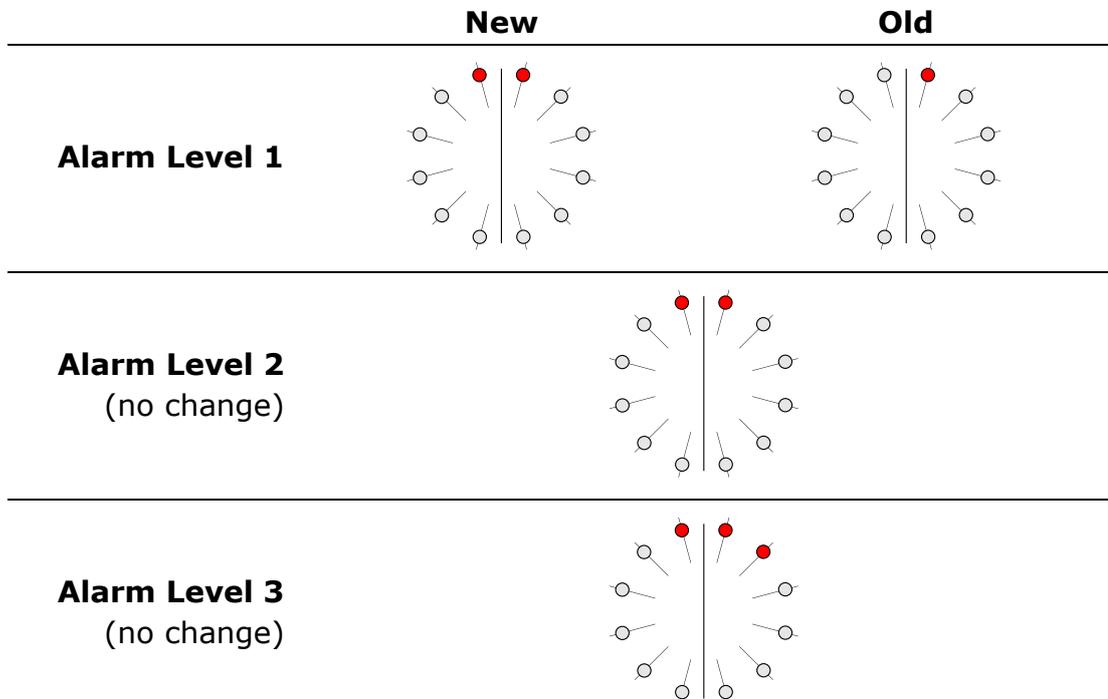
**Note:** Head-on ( $\pm 15^\circ$ ) traffic and collision warnings on Classic FLARM F6–F9 are indicated as shown in the graphic below (the traffic in this example comes from  $+5^\circ$  relative bearing).
